## Incident Investigation

### PM3 Breast roll cable failure, 11 December 2008

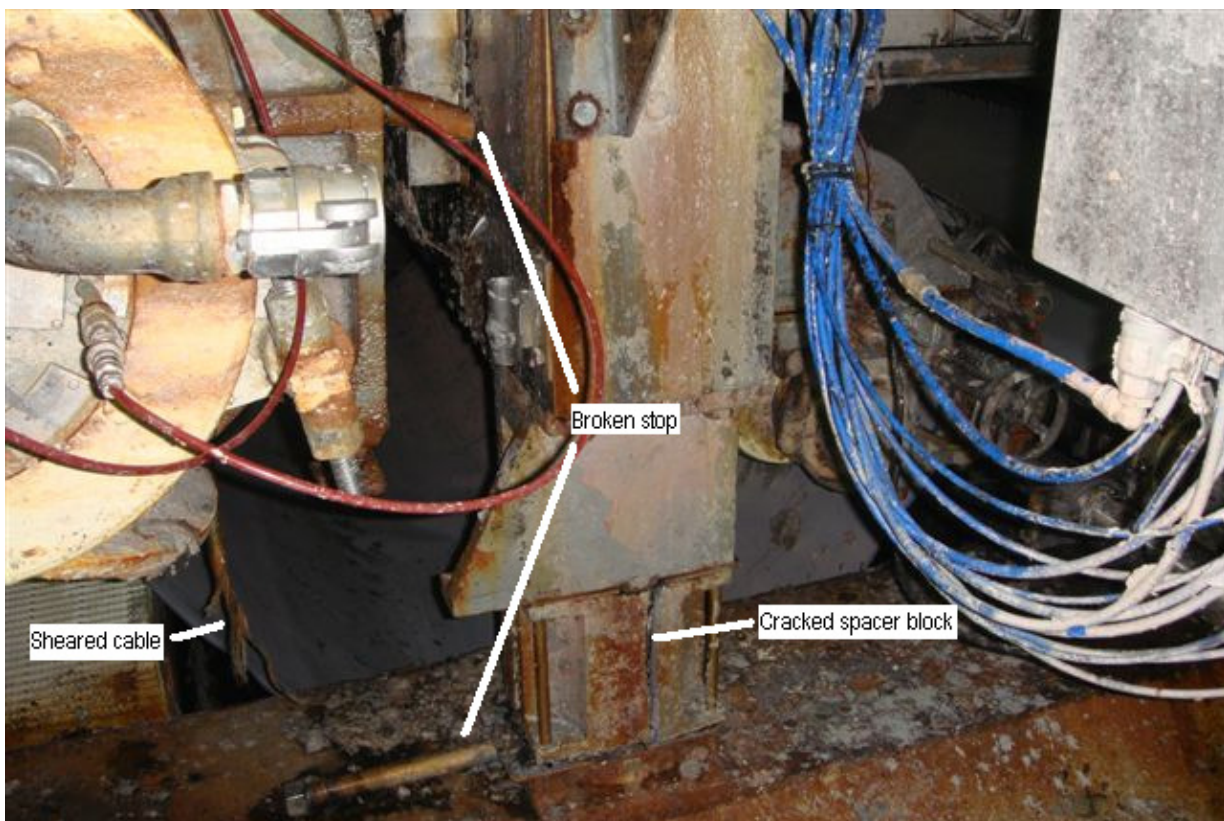
Fig 1

Senior operator had positioned himself at the front of the machine as per standard practice. Machine assistant was instructed to operate the backside switch. Dryerman was instructed to be the observer. Senior operator made all visual checks as per the procedure. Senior operator was satisfied all was ready for safe raising of the breast roll. Senior operator instructed assistant to engage his switch and Senior operator did likewise. The roll was raised to a 45 degree angle where it was stopped. Senior operator then made his visual checks and all cables were sitting in their correct positions. Senior operator instructed Assistant to engage his switch and the breast roll was again raised. When the breast roll was within 40mm of the home position without warning the front side cable sheared followed by the rear due to excessive load causing the breast roll to fall from its suspended pivotal arc position. This failure resulted in the breast roll colliding with the machine frame making significant impact which caused damage to the immediate area. (Fig 1 shows some of the localised damage on the front side)

The breast roll mechanism on PM3 is old technology to what is currently available in today's market it requires extensive human skill involvement which exposes potential human error. An alternative mechanical screw jack mechanism is available which eliminates human error completely. This will be added to the recommendations.

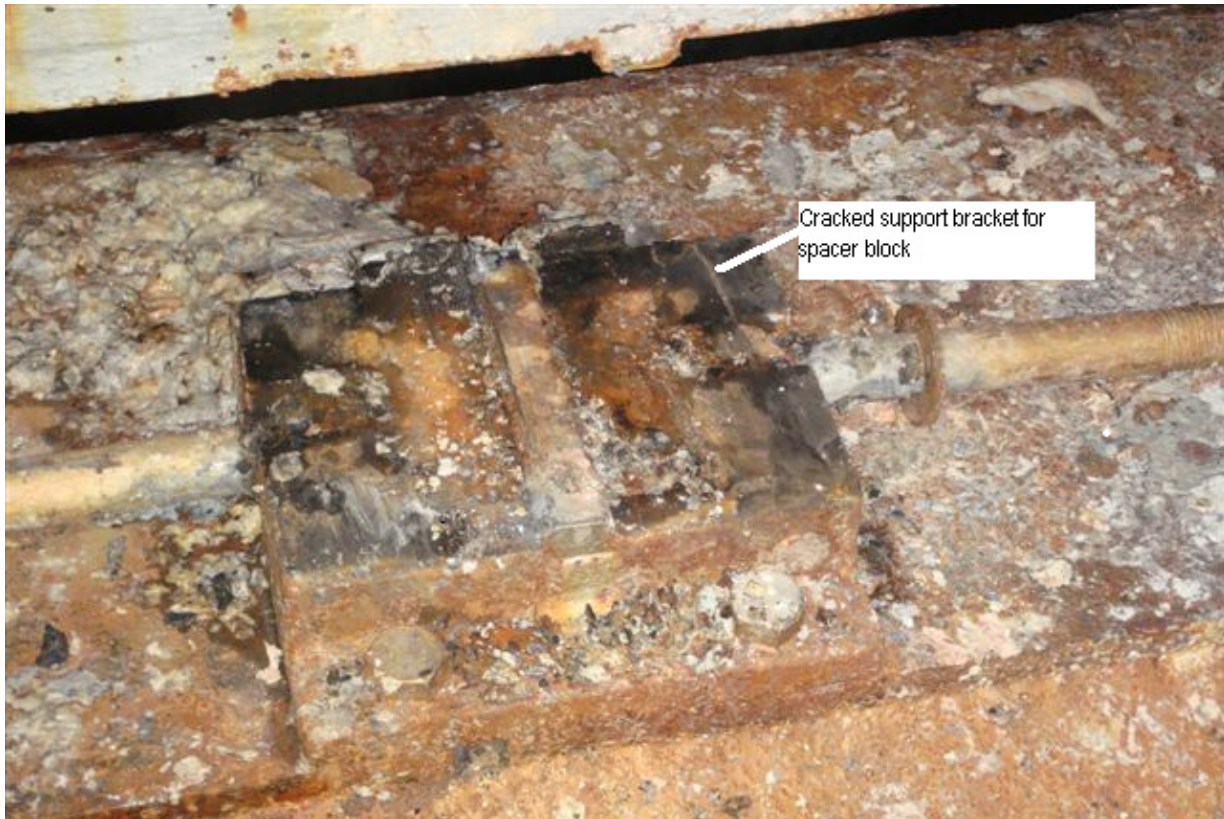
**Fig 2** shows a crack in the floor mount which supports the spacer block. This support took the brunt of the impact.

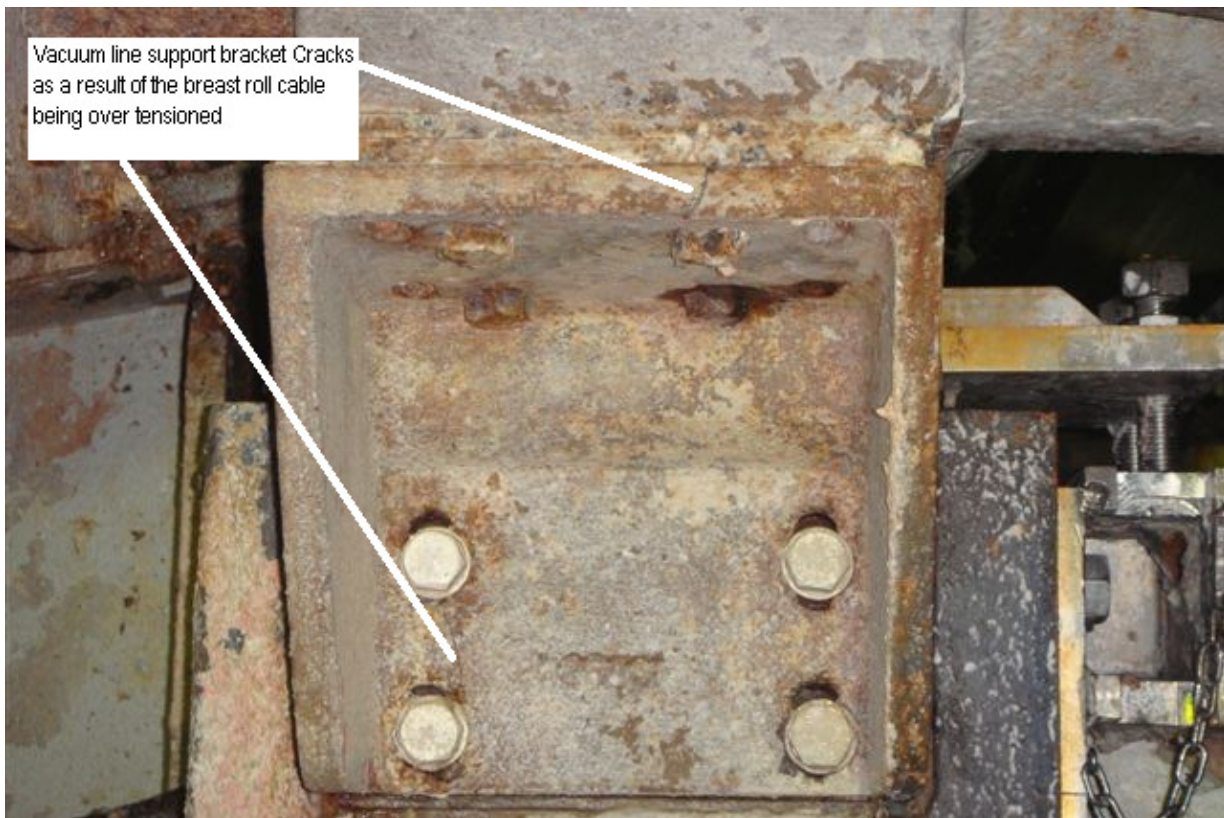
**Figure 3**

The cracked bracket shown in fig 3 supports the vacuum pipe flange, this is a tell tail sign that excessive force has been applied to the bracket. The only way this could have happened is the breast roll flange has pushed against the fixed flange causing an upward force which has stressed the bracket resulting in the crack.

The cracked bracket holding the vacuum pipe flange, the bending of the cable pin, and bent stopping block indicates that excessive tension had been applied to the lifting cable.
