03 April, 2009

SAFETY ALERT

Paper Machine Breast Roll Cable Failure

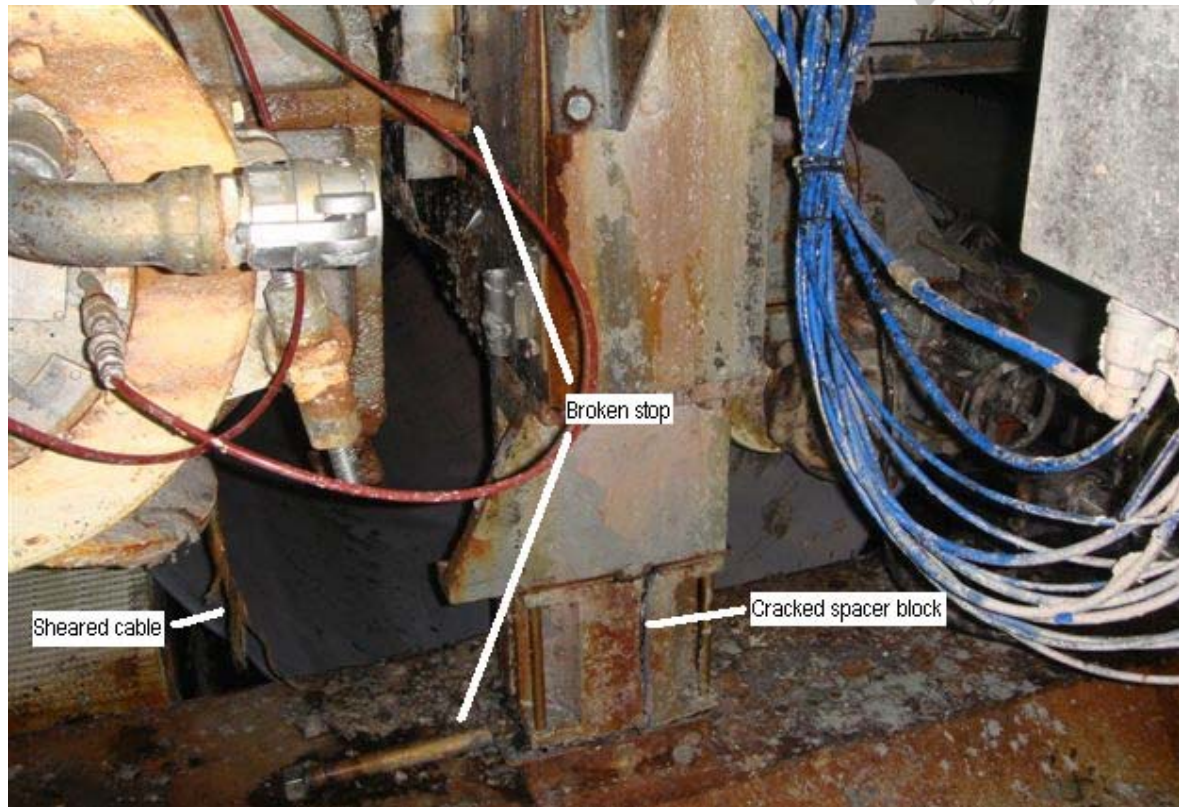
Fig 1

Dryerman was instructed to be the observer. Senior operator made all visual checks as per the procedure. Senior operator was satisfied all was ready for safe raising of the breast roll. Senior operator instructed assistant to engage his switch and Senior operator did likewise. The roll was raised to a 45 degree angle where it was stopped. Senior operator then made his visual checks and all cables were sitting in their correct positions. Senior operator instructed Assistant to engage his switch and the breast roll was again raised. When the breast roll was within 40mm of the home position without warning the front side cable sheared followed by the rear due to excessive load causing the breast roll to fall from its suspended pivotal arc position. This failure resulted in the breast roll colliding with the machine frame making significant impact which caused damage to the immediate area. (**Fig 1** shows some of the localised damage on the front side)

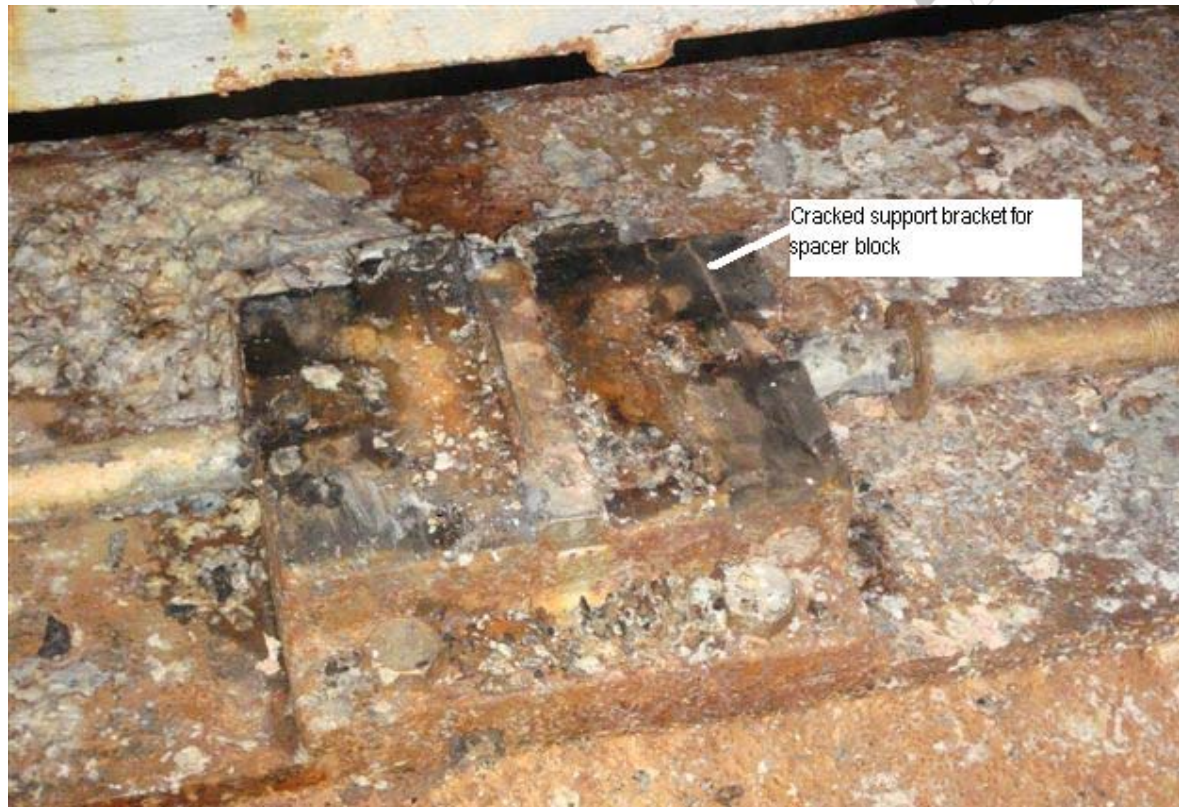
Fig 2 shows a crack in the floor mount which supports the spacer block. This support took the brunt of the impact.

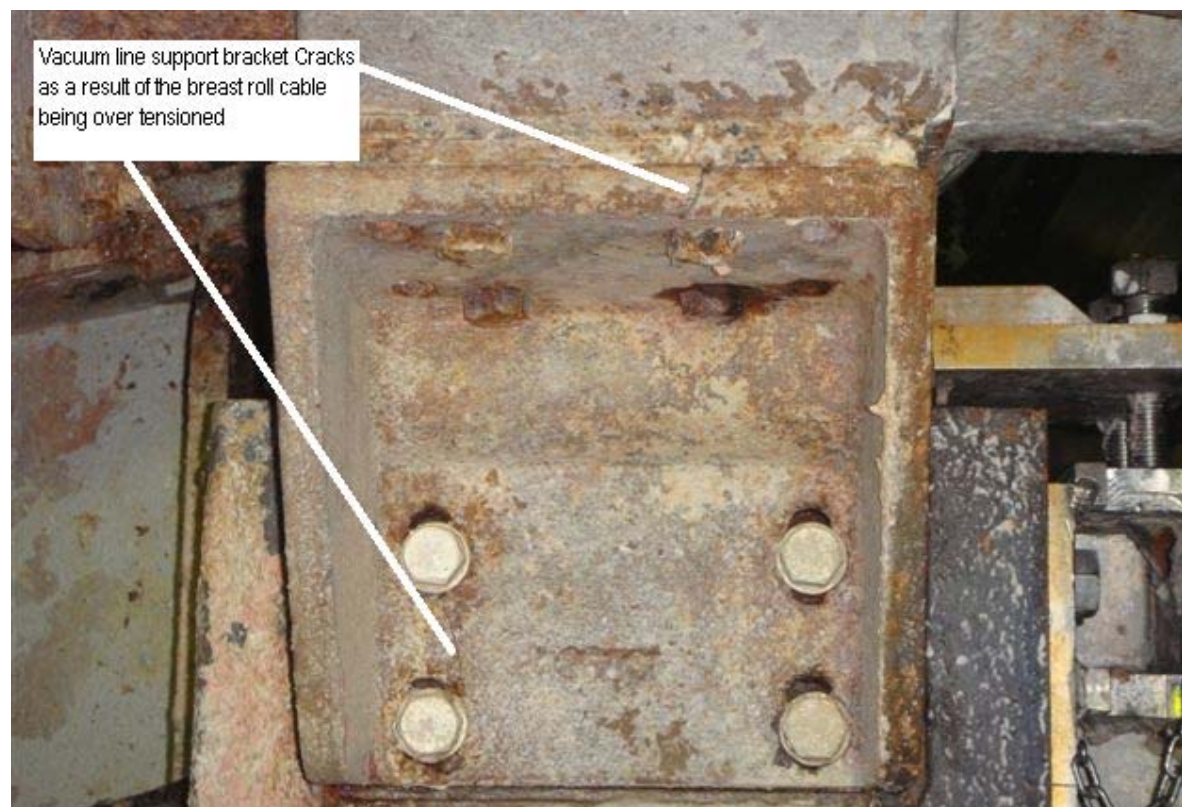
Figure 3

The cracked bracket shown in fig 3 supports the vacuum pipe flange, this is a tell tail sign that excessive force has been applied to the bracket. The only way this could have happened is the breast roll flange has pushed against the fixed flange causing an upward force which has stressed the bracket resulting in the crack.

The cracked bracket holding the vacuum pipe flange, the bending of the cable pin, and bent stopping block indicates that excessive tension had been applied to the lifting cable.
